Review of Problem Tooling Breakdown Fixes at the Op10 Part Panel Anniversary, RR W/House Inn, RR L/R (RH) at PT. Summit Adyawinsa Indonesia

Keywords: dies stamping, tooling breakdown, preventive maintenance, fishbone diagram, 5why analysis

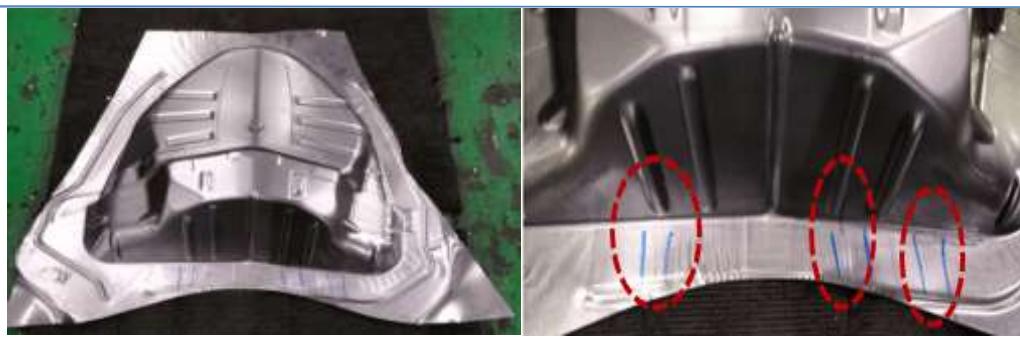
Fig. 2: Part Scratch
Source: Author's Processing Results, 2025

The company conducted a Root Cause Analysis (RCA) on the damage to the OP10 dies that caused scratch *part* defects. Based on field findings, damage occurred to the blank holder insert in the form of pin holes and a peeling layer of hardchrome. Initial solution: insert modification using steel material and recoating to prevent repeated damage.

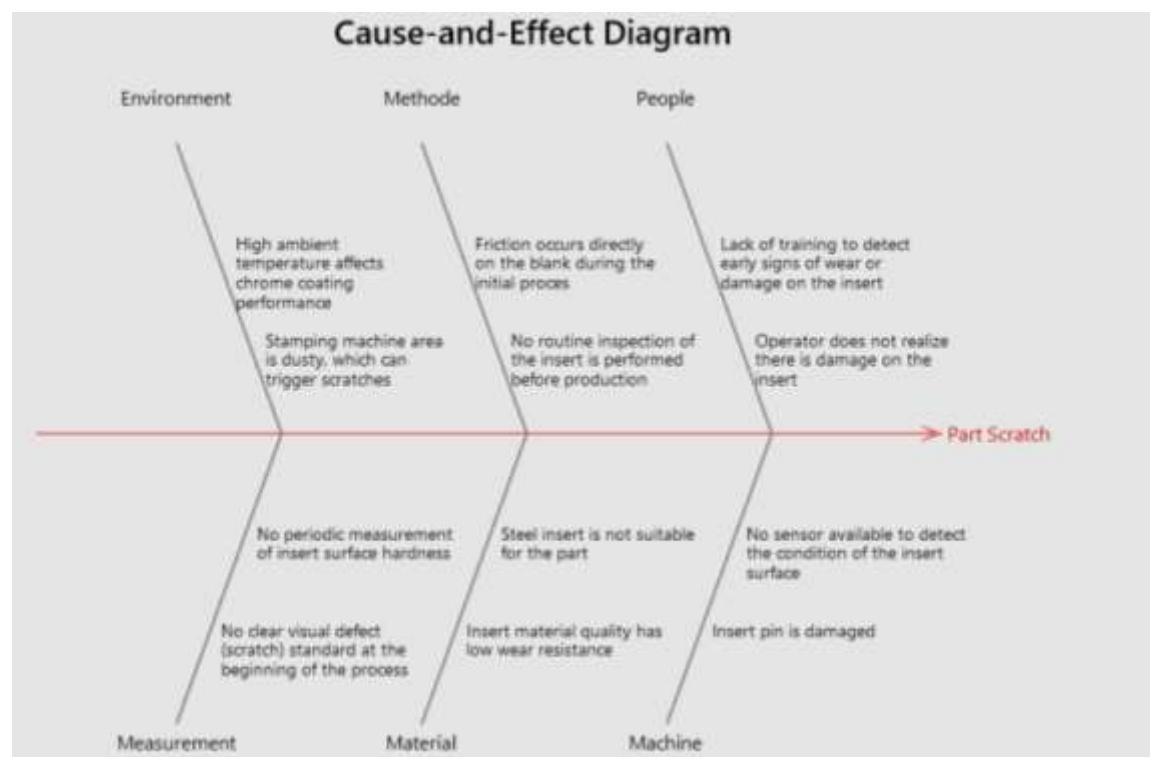
Fig. 12: Proses Coating dan Re-hrd Chrome
Source: Author's Processing Results, 2025

Fishbone analysis was used to identify the causes of *scratches* in RR W/House Inn RR L/R Panel parts from the aspects of machinery, materials, methods, humans, environment, and measurements.

The results of the analysis showed that *scratch* was caused by worn inserts, damage to pin holes and hardchrome coatings, lack of routine inspections, suboptimal operator skills, less supportive working environment conditions, and no standard for measuring surface roughness. Therefore, improvements are directed at insert modifications, improvement of inspection SOPs, operator training, and strengthening of the tooling monitoring system.
