# Implementation of Non-Destructive Radiographic Testing for Welding Defect Inspection on Heat Exchanger Project DXXXX at PT XYZ

**Marizka Putri Ismawaty\***, **Dene Herwanto**, **Naufal Rabbani Sumitra**, **Benyamine Sulaeman**

Industrial Engineering Department, Universitas Singaperbangsa Karawang, Jawa Barat

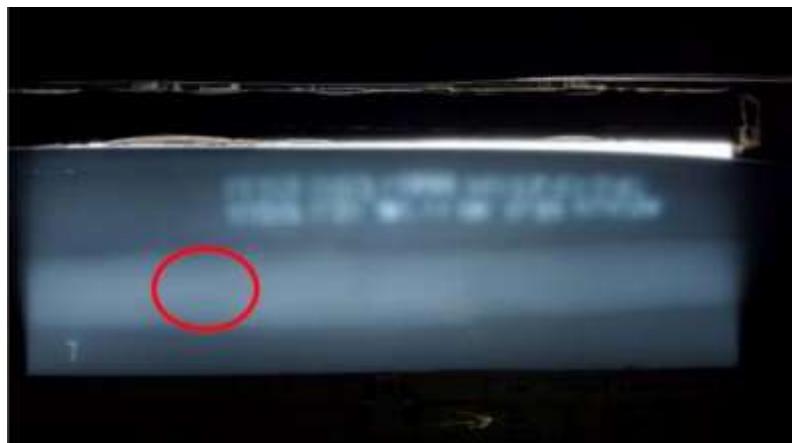
**Fig. 2:** WL.A-6  
Source: PT XYZ, 2025

and WL. C-5, while the Porosity defect type is detected in WL. B-8 and WL. C-7. The radiographic film sample shows the details of each defect, as shown in **Figure 2** (WL. A-6) and **Figure 3** (WL. A-7) showing the Slag Inclusion on the longitudinal shell joint, as well as **Figure 4** (WL. B-4) and **Figure 5** (WL. B-6) which shows a similar defect in the circum shell connection.

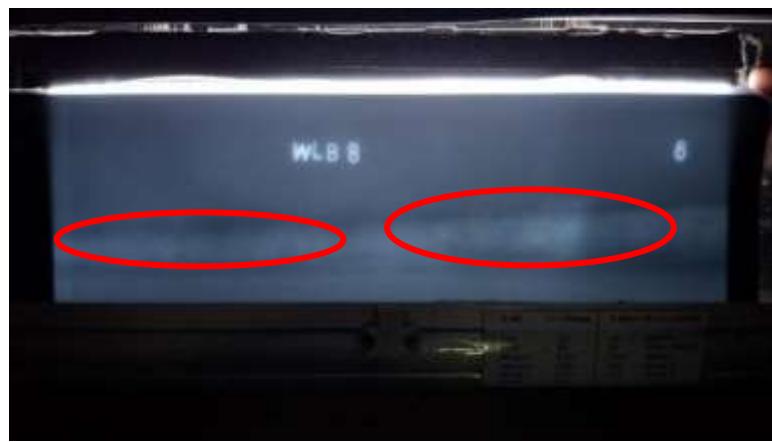
**Fig. 6: WL.B-8**  
Source: PT XYZ, 2025

The porosity defect is clearly visible in Figure 6 (WL. B-8) and Figure 11 (WL. C-7), are located at the circum shell and flange to pipe joints, respectively. Meanwhile, the Slag Inclusion defect in the other section is shown in Figure 7 (WL. C-1), Figure 8 (WL. C-2), Figure 9 (WL. C-4), and Figure 10 (WL. C-5), which includes flange to channel, channel to tubesheet, and flange to shell connections. Overall, the radiography film data clarifies the distribution and type of weld defects that occur in some critical areas of the Heat Exchanger components.

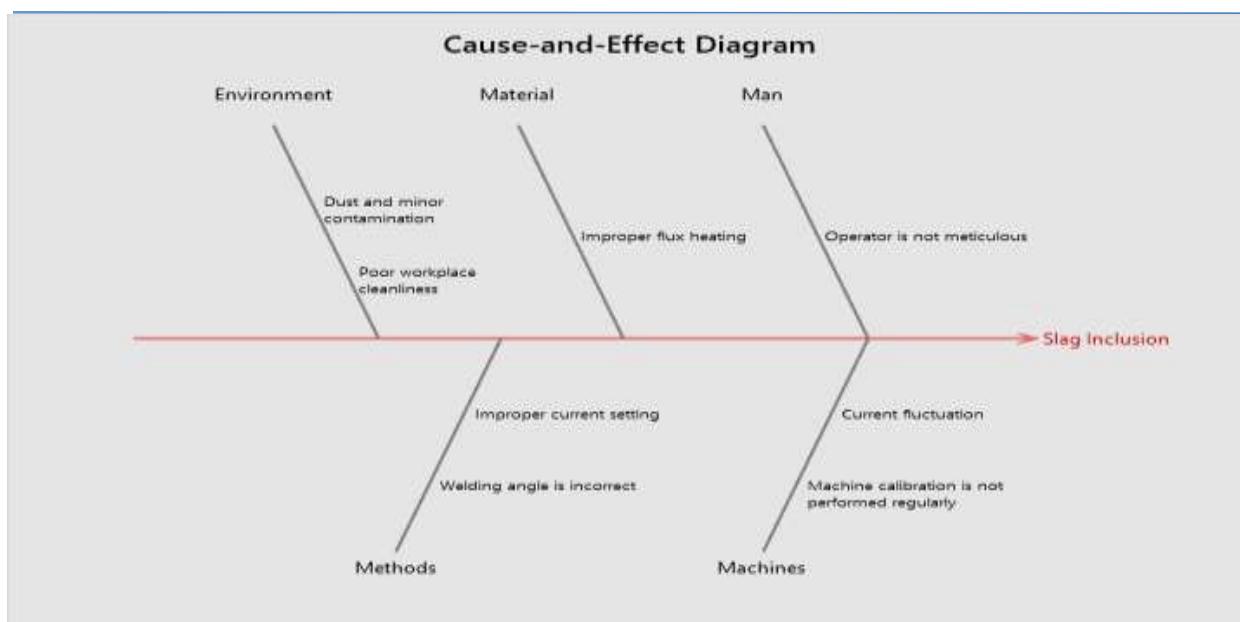
**Fig. 12:** Fishbone Diagram Slag Inclusion

Based on the results of the analysis using the fishbone diagram on *slag inclusion* defects, as shown in **Figure 12** Fishbone Diagram Slag Inclusion, it is known that this defect can be caused by several main factors. From the Man aspect, the operator is not thorough in cleaning the weld layer so that the remaining slag is left behind and trapped in the weld. From the Machine side, the current instability and the absence of periodic calibration of the welding machine cause the welding quality to be inconsistent. In the Method factor, incorrect adjustment of welding angles also triggers the formation of slag inclusion. From the material factor, flux heating that is not in accordance with the provisions on the manufacturing data sheet makes the flux not work optimally so that residual particles can be left at the joint. Meanwhile, environmental factors such as unclean work areas and the presence of dust or light contaminants also have the potential to enter the welding area and cause these defects.

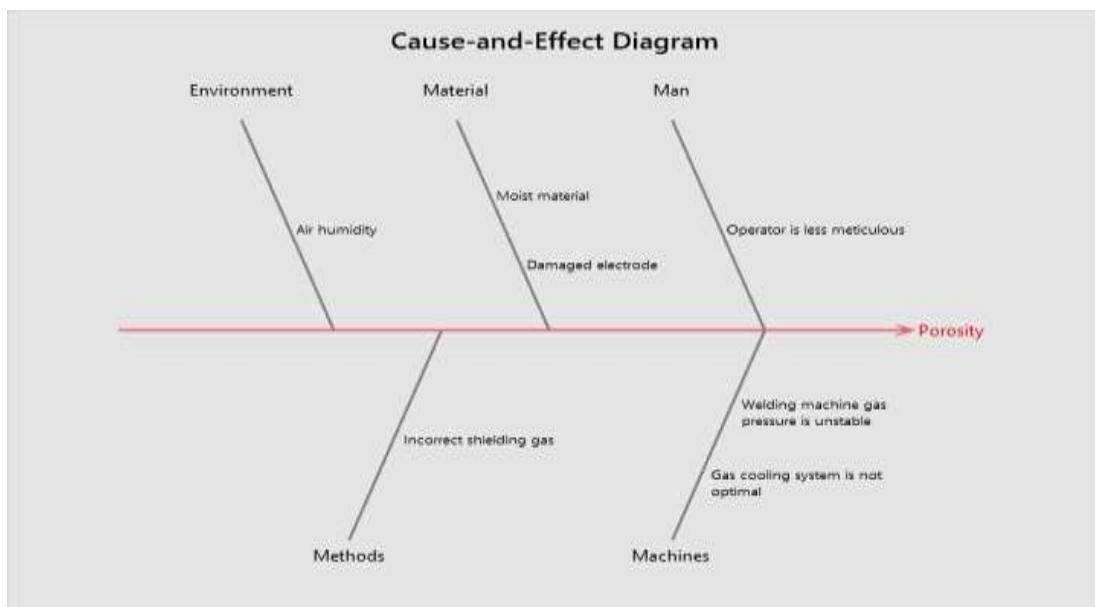
**Fig. 13:** Fishbone Diagram Porosity

Based on the analysis using fishbone diagrams for porosity defects, as shown in Figure 13 of the Fishbone Porosity Diagram, it is known that these defects are influenced by several main factors. From the Man aspect, the operator is not meticulous in preparing the surface of the material so that the contaminants left behind can release gases when exposed to the welding heat and trapped before the metal freezes. In the Machine factor, unstable gas pressure due to suboptimal regulator settings and inadequate gas cooling systems can increase the temperature and encourage the formation of gases. In terms of method, the use of gas shielding in the GTAW method that is not suitable also triggers the formation of porosity. In the Material aspect, moisture in the base material or electrode and the use of damaged electrodes can produce hydrogen gas during the welding process. Meanwhile, environmental factors such as high air humidity and moisture in the work area can also enter the welding zone, causing small gas cavities to form in the metal that freeze too quickly.
