# Coastal Morphological Characteristics and Environmental Factors Causing Abrasion at Moilong Beach Based on GIS Analysis

## Abstract

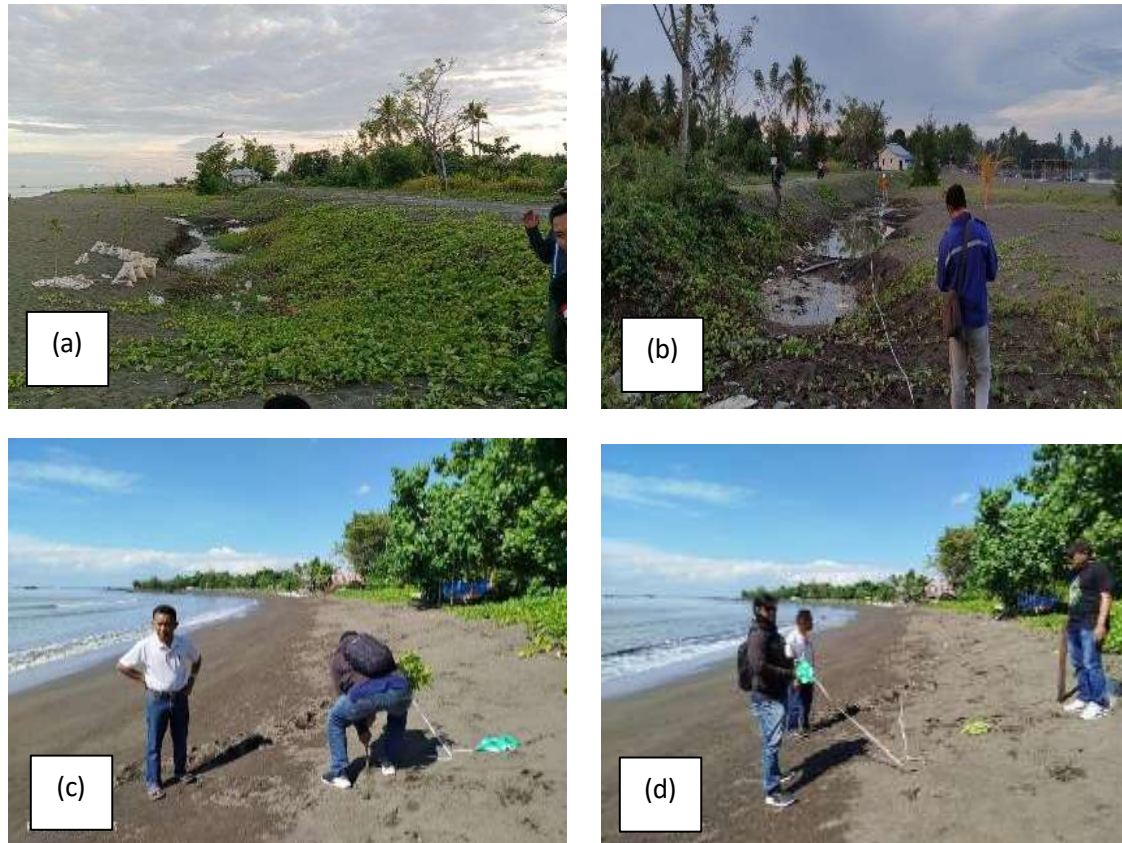
**Fig.1.** (a) before the construction of the seawall (b) erosion basin (c) shoreline retreat (d) loss of coastal areas  
(Source: Public Works and Spatial Planning Agency, 2023)

Field observations also revealed that structural coastal protection remains limited. The existing seawall protects only approximately 200 m of the 700 m shoreline investigated, leaving a large proportion of densely populated coastal segments without adequate protection. In addition, several public facilities and aquaculture ponds are located near the shoreline, increasing the potential for economic and social losses if erosion continues. These findings indicate that structural protection alone is currently insufficient to reduce coastal risk, particularly in areas where population density and infrastructure concentration are high. Recent studies similarly emphasize that the effectiveness of coastal protection depends on integrating engineered structures with ecosystem-based adaptation and appropriate spatial planning to reduce long-term exposure [31],[2].

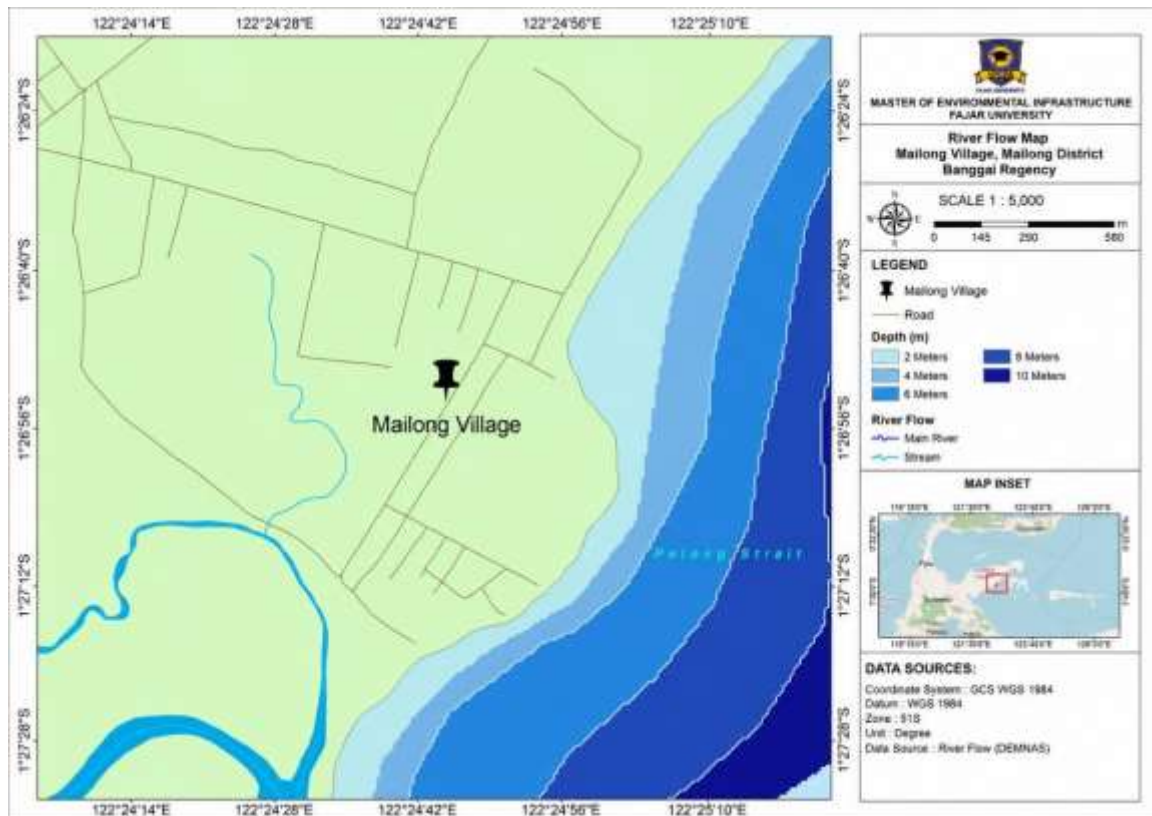
Fig. 5. River Flow Map of Moilong Village, Moilong District, Banggai Regency

The watershed analysis identified one main river and a smaller tributary discharging into the coastal waters of Moilong Beach. These river systems function as the primary pathways transporting sediments from the upstream catchments to the coast, thereby maintaining the coastal sediment budget. Spatial observations indicate that the main river drains a larger catchment before reaching the Peleng Strait, whereas the tributary traverses the central settlement area and contributes additional sediment inputs to the northern coastal segment. These findings highlight the important role of watershed characteristics in controlling sediment availability and coastal morphology.
